## **A Neighborhood Approach to Build Resilience and Repair Shelters (NABuRRS)**

**Overview of the evacuation center assessments performed in Sud, Sud-est, Grand Anse and Nippes.**

### **WORLD CONCERN DEVELOPMENT ORGANIZATION HAITI February 2021**

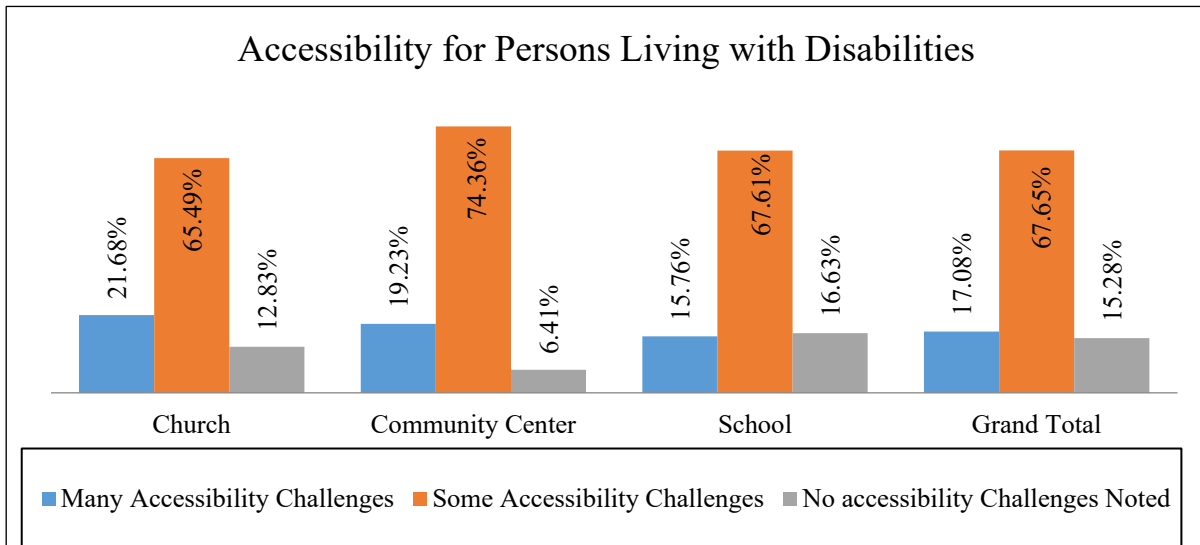
Figure 4: Accessibility for Persons Living with Disabilities

According to the data from this evaluation, only 15.28% of the shelters are accessible to people with disabilities. This proportion is more than 2 times lower in the community centers (6.41%) than in the whole.

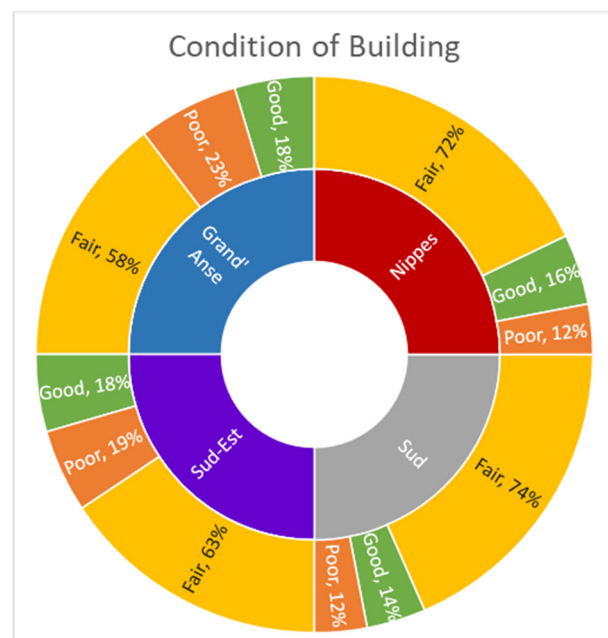
Figure 5: Condition of Building

Both the general condition of each building at every center was assessed as well as a determination of its seismic and wind vulnerability. Buildings were generally in fair condition (65%) but up to 18% were in poor condition (see Figure 4). Grand' Anse proved to be the department with worst condition buildings with 23% of the structures in poor condition.

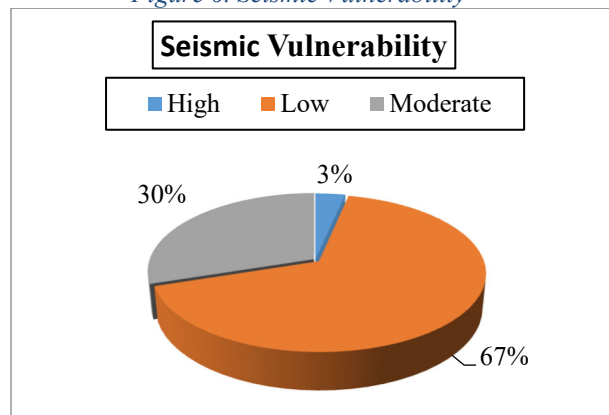
*Figure 6. Seismic Vulnerability*

A significant number of buildings showed vulnerabilities, the most common of which was a lack of proper connections. This will be important to address when performing the detailed design, which could reveal more significant structural vulnerabilities.

- It can be elaborated that the seismic evaluation approaches have been used to specify and estimate the structure's capacity to withstand an earthquake. For the seismic vulnerability, 67% of the buildings have low vulnerabilities. Those parameters can affect the collapse of a structure moreover. For the upgrading of the shelter with light seismic damage it is necessary to design parameters that have a direct impact to control the structural behavior either by considering the past damage observations or by expecting the damaged spot in the structure.

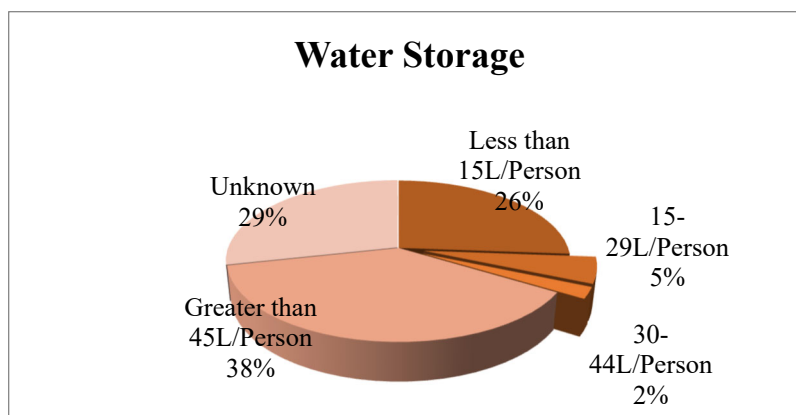
*Figure 10. Water Storage per Person*

When one accounted for the SPHERE maximum occupancy, 33% of shelters had less than 45L/person (26% with less than 15L/Person, 5% with 15-29L/Person, and 2% with 30-44L/Person, see figure below). A shelter should ideally have storage adequate for 3 days with a minimum of 15L/occupant/day. This does not consider the presence of flush toilets either in which case 20L/occupant/day should be required as a minimum. 38% of shelters have this adequate storage or more. See online dashboard for finer detail of data (Linked in Appendix 1).

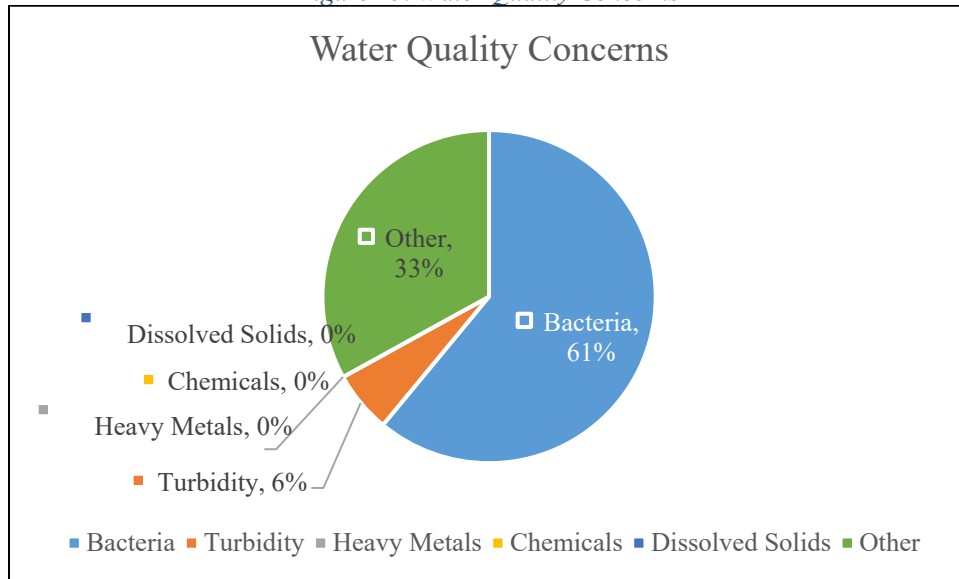
Figure 15: Water Quality Concerns

The most commonly known water quality issue was the presence of bacteria (61%, see Figure 15). A large portion of centers had “Other known water quality” issues (33%). For those shelters selected, water testing will be conducted in the detailed assessment and proper treatment determined. See online dashboard for more water treatment data. (Linked in Appendix 1)

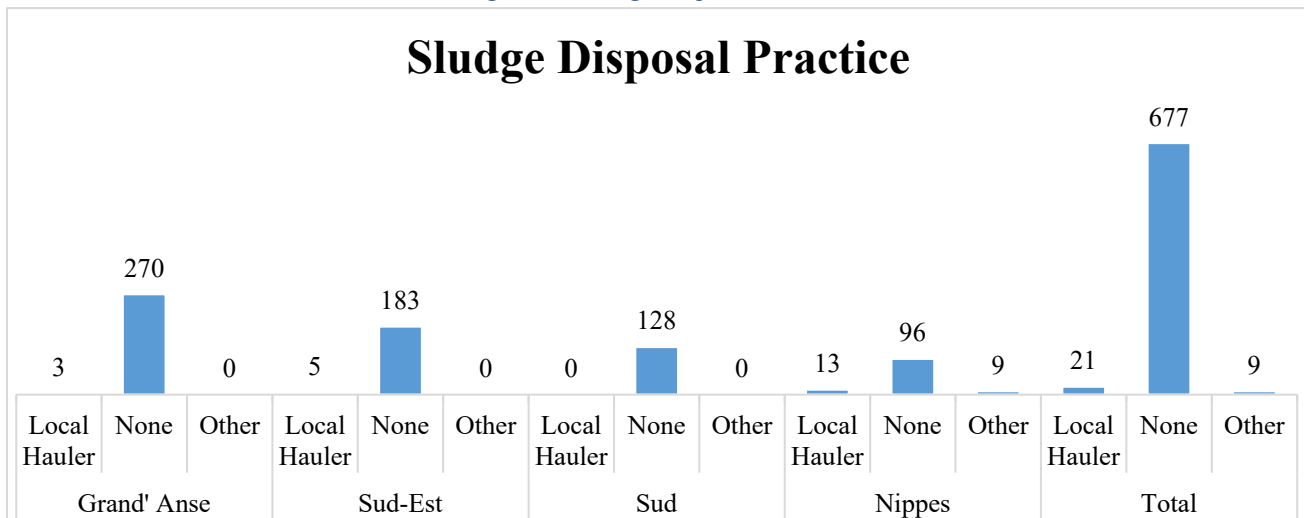
Figure 16. Sludge Disposal Practice

Of note, most facilities did not have any kind of sludge disposal practice in place (96%, see Figure 12). This will be a critical area to address when upgrading facilities. Many sanitary blocks were determined to need minor repair. For selected centers, the exact type of repair necessary will be determined during the detailed assessment. See online dashboard for greater sanitation data. (Linked in Appendix 1)

- According to the assessment, around 96% of evacuation centre do not have adequate sludge disposal. Therefore, it is important to establish disposal system in coordination with DINEPA while applying national standards. This must be done together with the collaboration with Regional Office of Drinking Water and Sanitation (OREPA) and local system specializing in waste management, management of excreta, and ground protection after the repair.

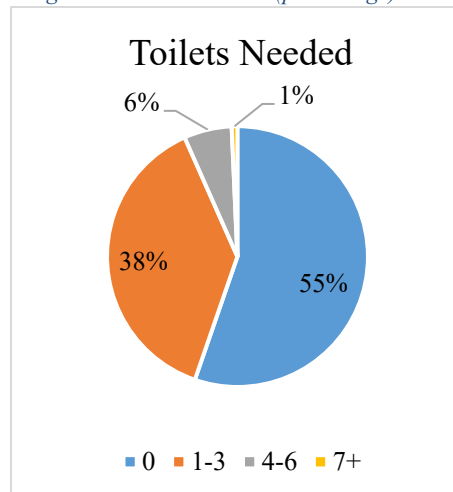
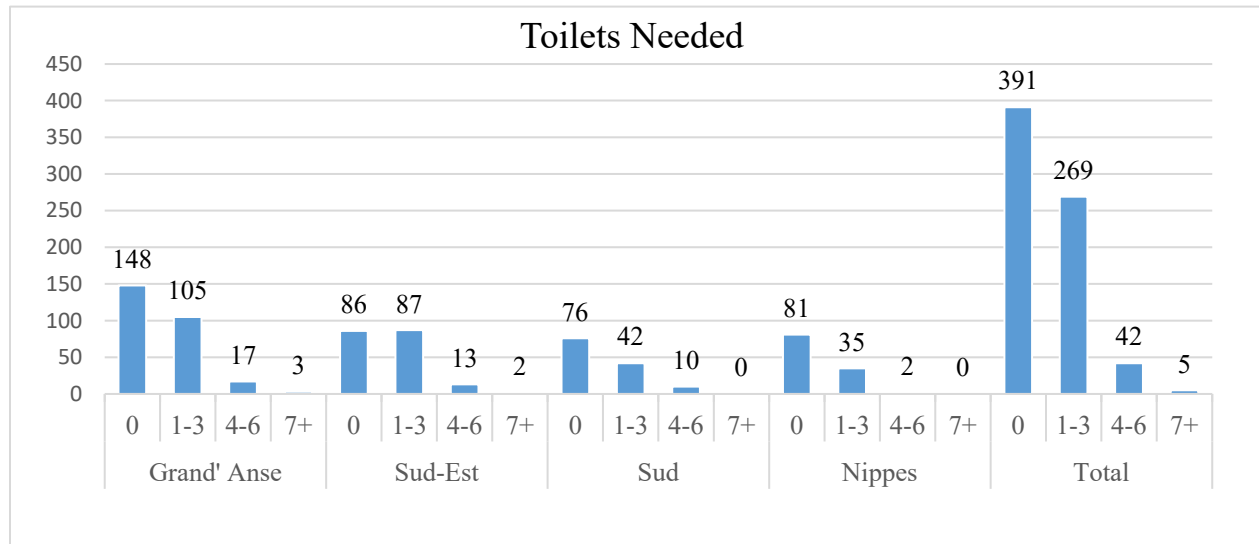
Lastly, the number of good or fair (i.e. useable) toilets per person (when considering the SPHERE capacity) was calculated as well. Approximately 45% of centers did not have an adequate number of toilets to serve the full capacity of center (see Figure 17). This assumes a 50 occupants/toilet per SPHERE guidelines for similar buildings (i.e. transit centers). For centers selected for upgrade, toilets blocks will likely need to be added or repaired.

- Damages in the sanitary facilities of some shelters are very common, while the building typology is in very good condition especially in rural communities. This requires intervention and awareness. Major damage to both rural and urban water systems, intermittent to no water supply, requiring extensive works and immediate intervention to ensure that at least one (1) toilet is available for twenty (20) people.
